SURFACE BYPASS AND COLLECTION SYSTEM DEWATERING SYSTEM FIELD INVESTIGATION

DEWATERING FUNCTIONAL DESIGN CRITERIA

PREPARED FOR
U.S. ARMY CORPS OF ENGINEERS
WALLA WALLA DISTRICT

PREPARED BY
STONE & WEBSTER ENGINEERING CORPORATION
J.O. No. 05570.02

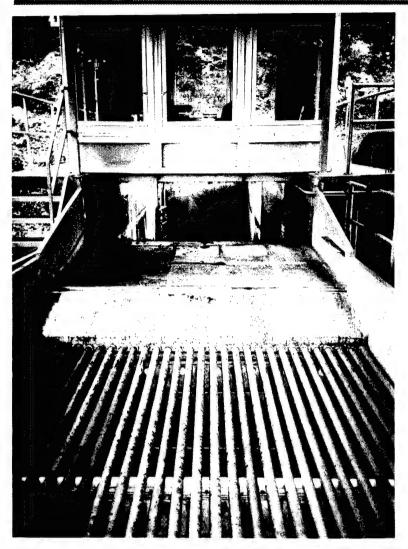
Upwell from underground fish transportation conduit (pressurized) behind operator booth. Floor screen (wire mesh) below operator booth with fish sorting facilities in foreground. Emergency bypass sluice gate on sidewall of upwell in background.

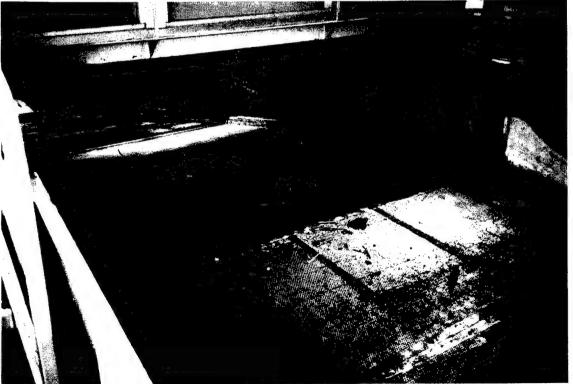
Primary dewatering in background with wire mesh over steel grating. Secondary dewatering in foreground with perforated plate.

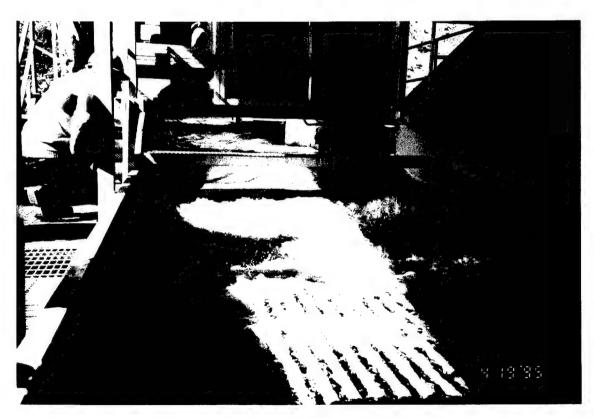
Upstream view of bypass discharge from upwell, passing through primary and secondary dewatering systems, and entering fish separator in lower portion of photo.

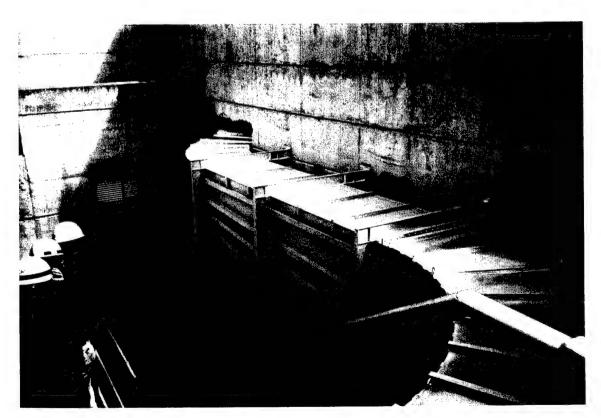
Fish collection flume exiting dam extending to dewatering facilities.

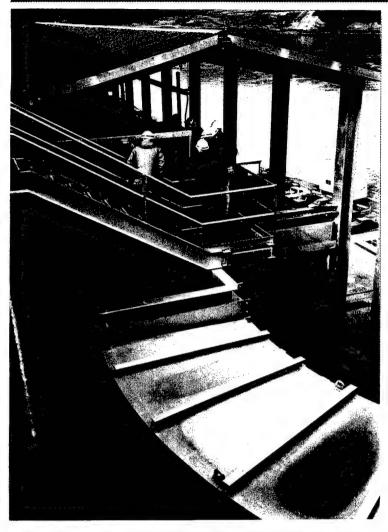
Fish collection flume connection to dewatering facility.

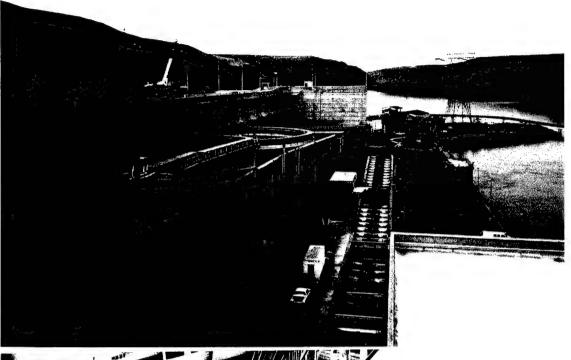
Fish transportation flume with loop to reduce effective slope extending from dewatering facility to fish handling facility.

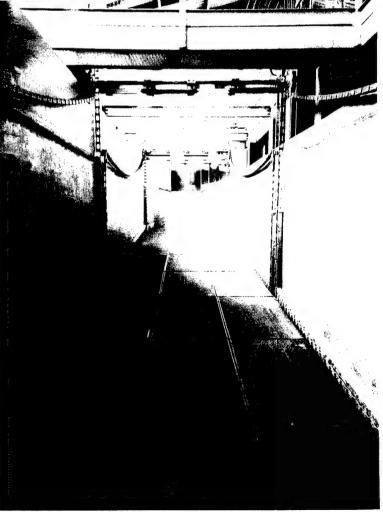
Floor dewatering screens with converging section at downstream end. Right wall lower than left for emergency bypass. Brush cleaning system with chains mounted on sidewalls.

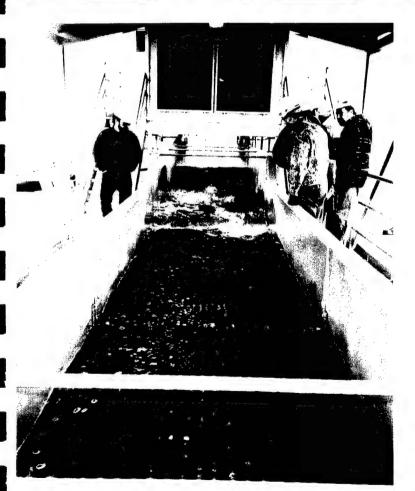
Upstream view of discharge into fish separator. Note turbulence in upper center of photo where floor dewatering system is located. Right and left halves of dewatering system cannot be adjusted to perform similarly.

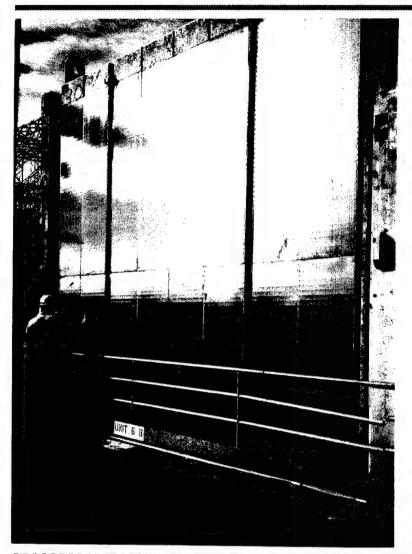
Extended submerged bar screen (ESBS) raised to operating deck level to be installed for testing during 1995 operations.

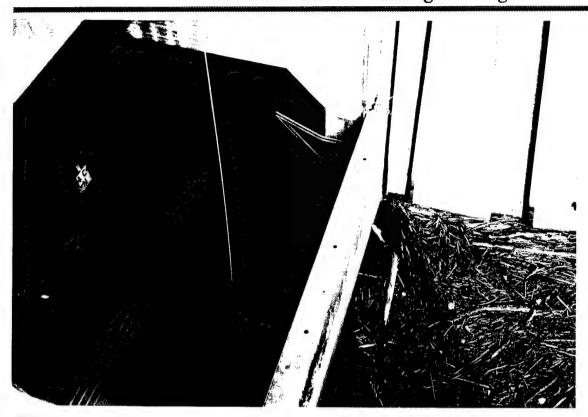
Ice/trash sluiceway weir gate between piers. Ice/trash sluiceway with collection channel in left of photo. Note the floating debris.

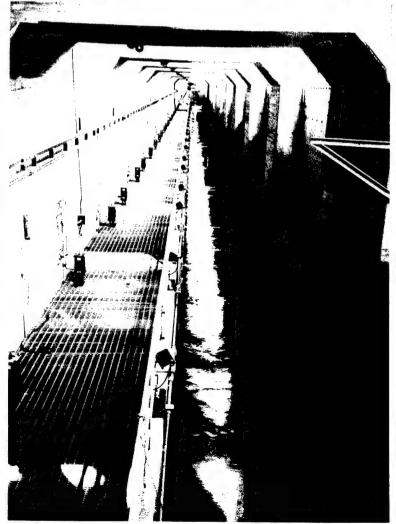
Ice/trash sluiceway converted to juvenile fish collection channel looking upstream. Knife gate operators for gatewell orifices above grating along left wall.

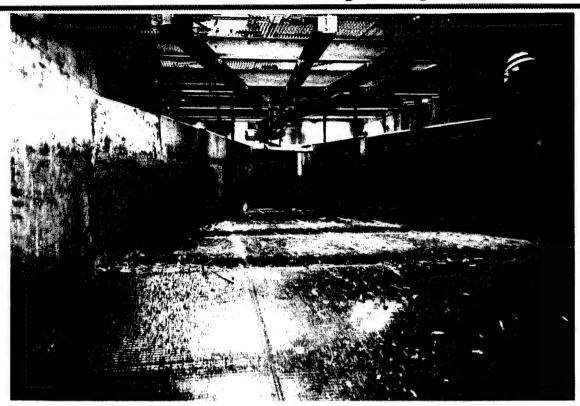
Floor dewatering system with bar screens looking downstream with converging walls and inclined floor screens. Beams mounted above support brush cleaning systems in converging section.

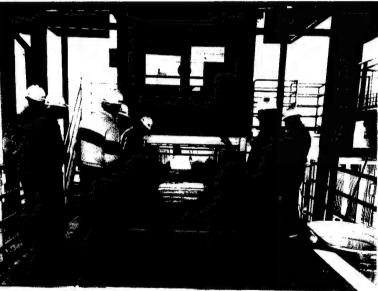
Fish sorting facility looking upstream toward outfall of fish transportation flume. (Sorting facilities similar at all projects visited.)

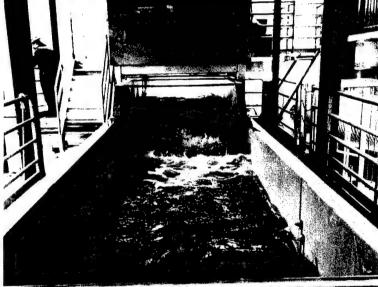
Upstream view of fish separator flowing about 30 to 40 cfs. No signs of juvenile fish passing through the system at this project on this date.

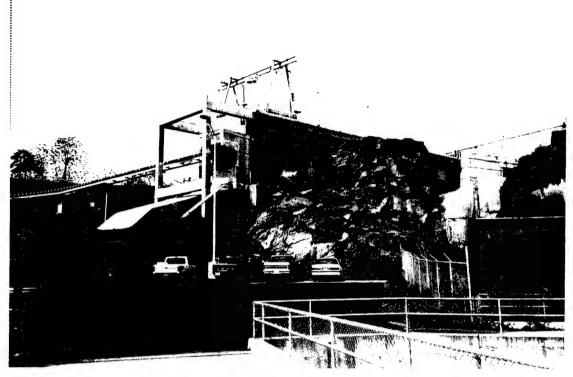
View of northshore fishway with penstock exiting structure to lower left. Note black bypass pipe exiting structure to left center of photo. The dam is to upper right with river behind photographer.

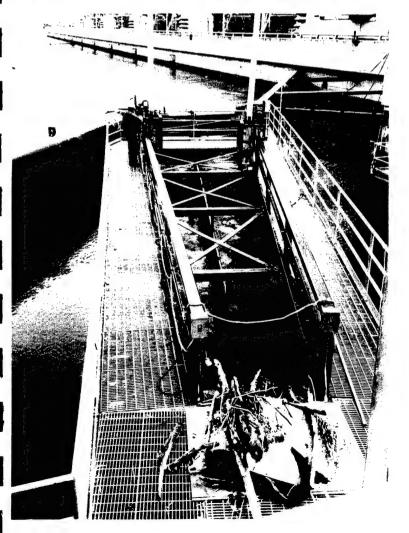
Upstream view of entrance channel and primary dewatering structure with center wall in channel for even flow distribution through screens. Dewatering discharge is drafted by powerhouse unit in upper right of photo using flap gates mounted in floor to throttle flow.

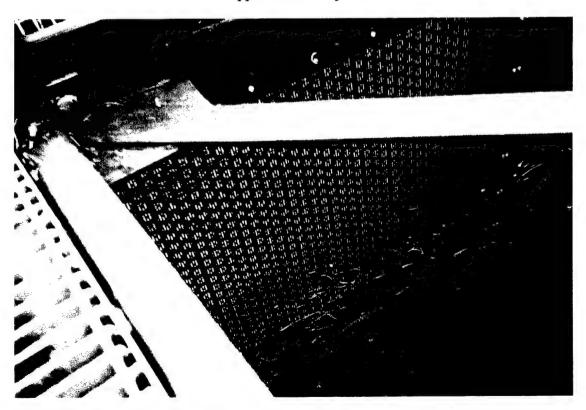
Slotted perforated plate on screening side of primary dewatering system with variable porosity circular perforated plate behind.

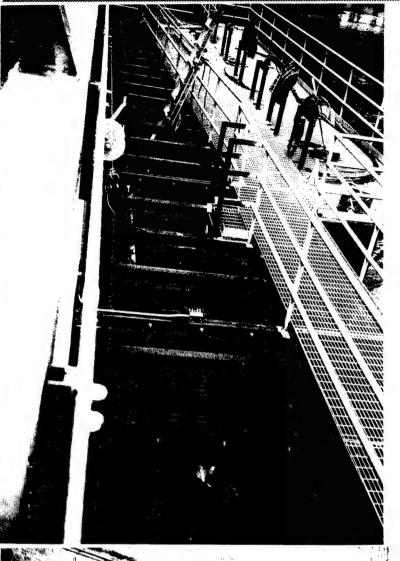
Downstream view of secondary dewatering channel. Note coarse trashrack in lower center of photo with grating above for cleaning personnel. Six weir gates in upper right of photo control removal of 80 cfs. Bypass discharge of 20 cfs continues through channel toward upper center of photo and into bypass pipe that passes through the dam.

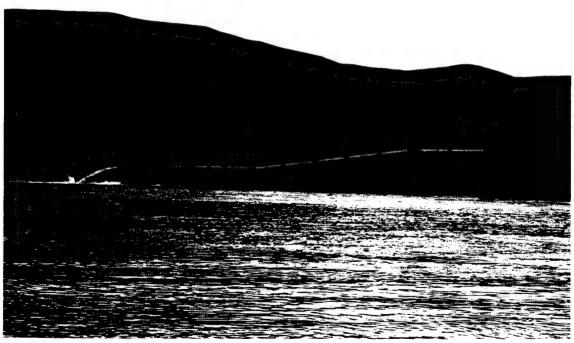
Bypass outfall piping (8-foot diameter) exits dam at end of powerhouse and discharges into tailrace. Bypass pipe discharge of approximately 500 cfs controlled by knife gate near the end of pipe.

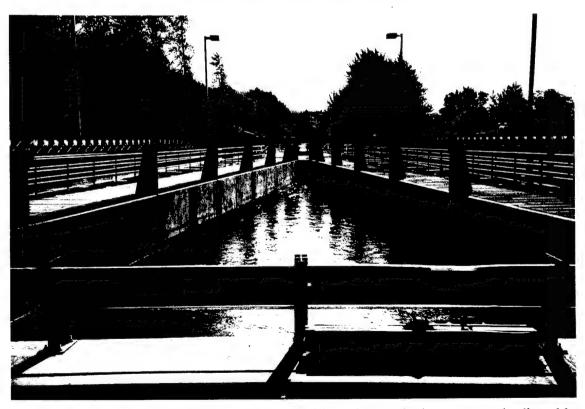
Downstream view of converging screening facility with vertical screens and adjustable porosity vanes. Bypass piping with weir gate at downstream end of converging section. Screen cleaning system rails along converging section deck.
